# PEUGEOT 205 GTI

HISTORY	1
SPECIFICATION	2
MODEL YEARS	4
COLORS	5
GUIDELINES	6
BASIC MAINTENANCE	8
WHEEL ALIGNMENT	10
COST	11
KNOWN PROBLEMS	12
BOOKS	13
BROCHURES	15

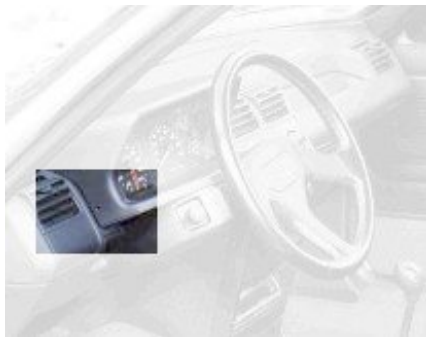
The instrument panel should not present any trace of disassembling. When holding firmly the instrument panel, it should not shake. Check the torx screw by the small hole at the left of the instrument cluster : if the screw is missing or has been replaced by another kind of screw, the instrument cluster has been removed and not well put back.

Try to locate any fingerprint into the instrument cluster.

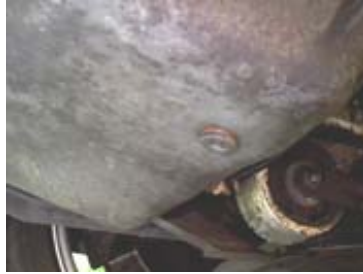
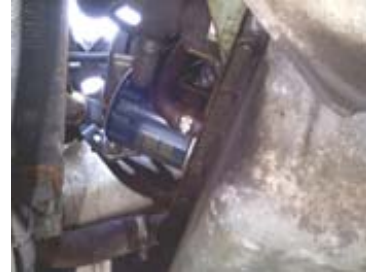
## Engine oil change + filter

A 8 mm square wrench will be necessary as well as an oil filter wrench. The oil filter is located in front of the engine, between the engine and the radiator.

Use semi-synthetic oil or 100% synthetic oil. Change oil every 3,100 mi or max 4,600 mi.

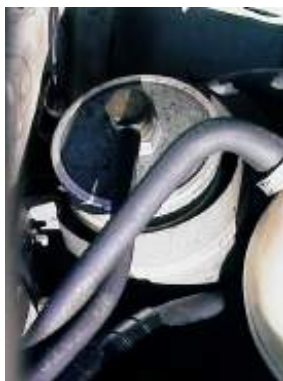
Fuel filter is the metal cylinder screwed close to the right strut mount area in the engine compartment. It must be changed every 50,000 mi.

Use new washers if necessary (peugeot part number 1562.56) when installing the new fuel filter.

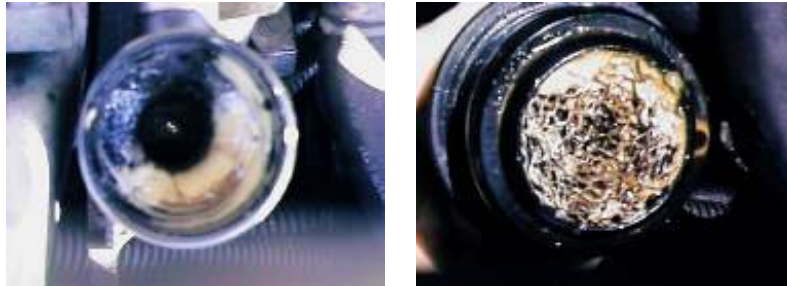
**Mayonnaise in oil filler cap** : it's mostly due to short trips. Clean oil filler cap at each oil drain. After high mileage, remove grill in oil filler cap and clean with solvent.
